## **REEF LIGHT INSPECTION CARYSFORT REEF LIGHT**

**UNITED STATES COAST GUARD  
OFFSHORE KEY LARGO, FLORIDA**

**USCG Task Order No.: HSCG82-10-J-PMV228  
Contract No.: HSCGG1-10-D-PRV090**

September 2010

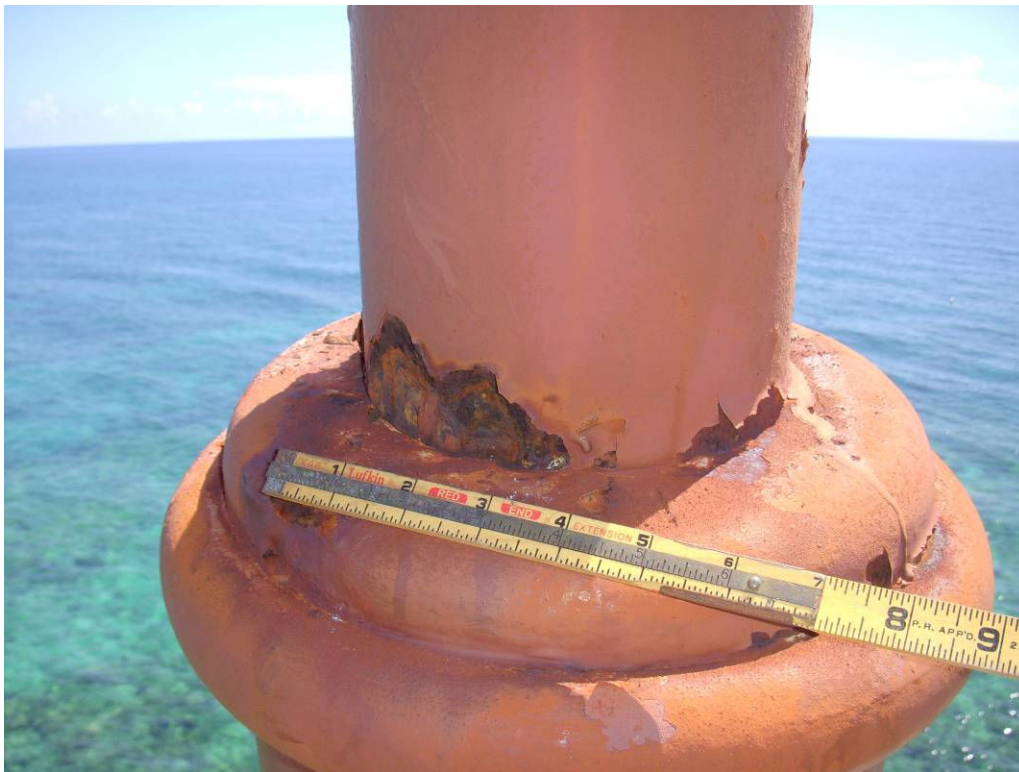
**Photo 6-2**

The columns are in **satisfactory** condition. Columns in Sections 1 and 2 have minor coating loss with previous pitting that has been painted over. This pitting is up to 3/8" deep in the 6" above and below the collars that join Sections 1 and 2 and up to 1/4" deep in the 2" above and below the intermediate collars within each section (Photos 6-2 and 6-3). Elsewhere, the columns in Sections 1 and 2 have isolated areas of pitting less than 1/16" deep.

Pitting above and below intermediate column connection collars.

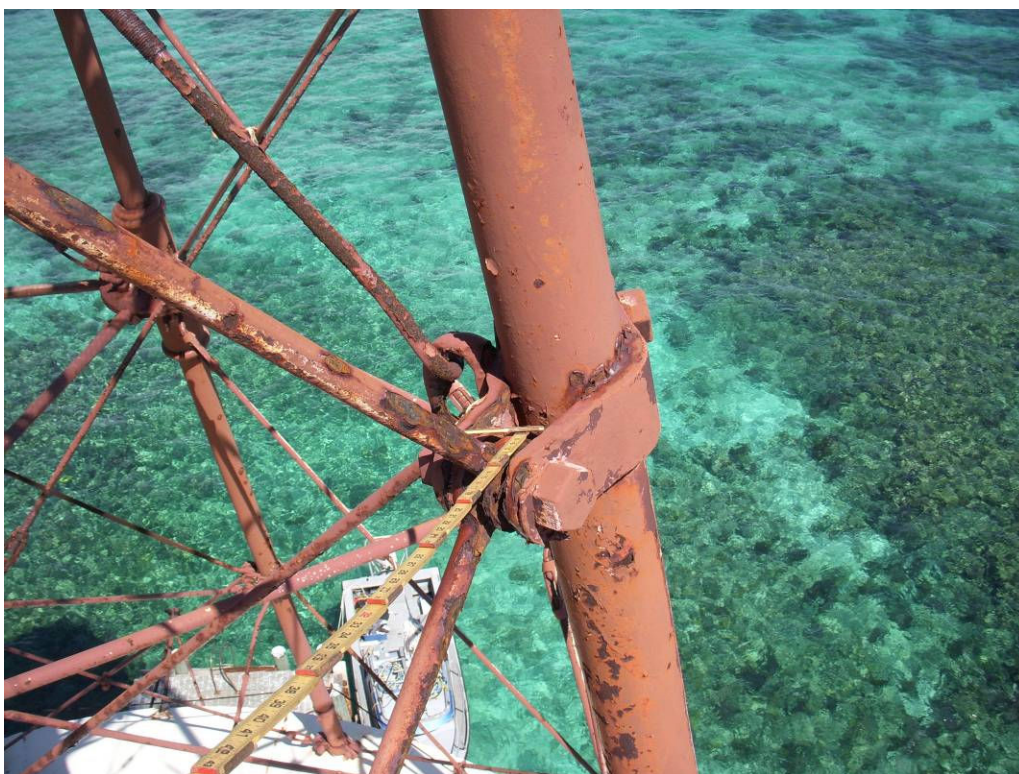
**Photo 6-3**

Pitting above and below intermediate tie rod connection collars.

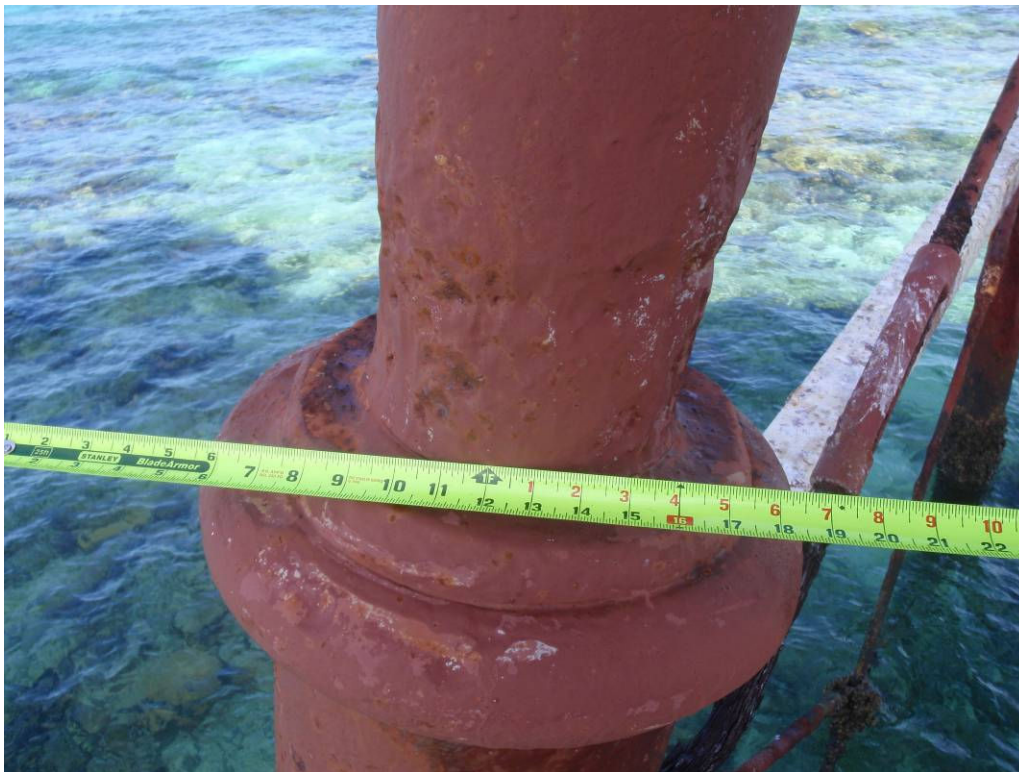
**Photo 6-4**

Columns in Section 4 have minor coating loss. The area 6" above the lower tie rod connections on columns 7 and 8 in Section 4 have previous heavy pitting up to 3/4" deep (Photo 6-4). Columns in Section 5 have 100% coating loss with heavy corrosion with areas of pitting up to 1/4" deep (Photo 6-5).

Heavy pitting above the lower tie rod connections on column, Section 4.

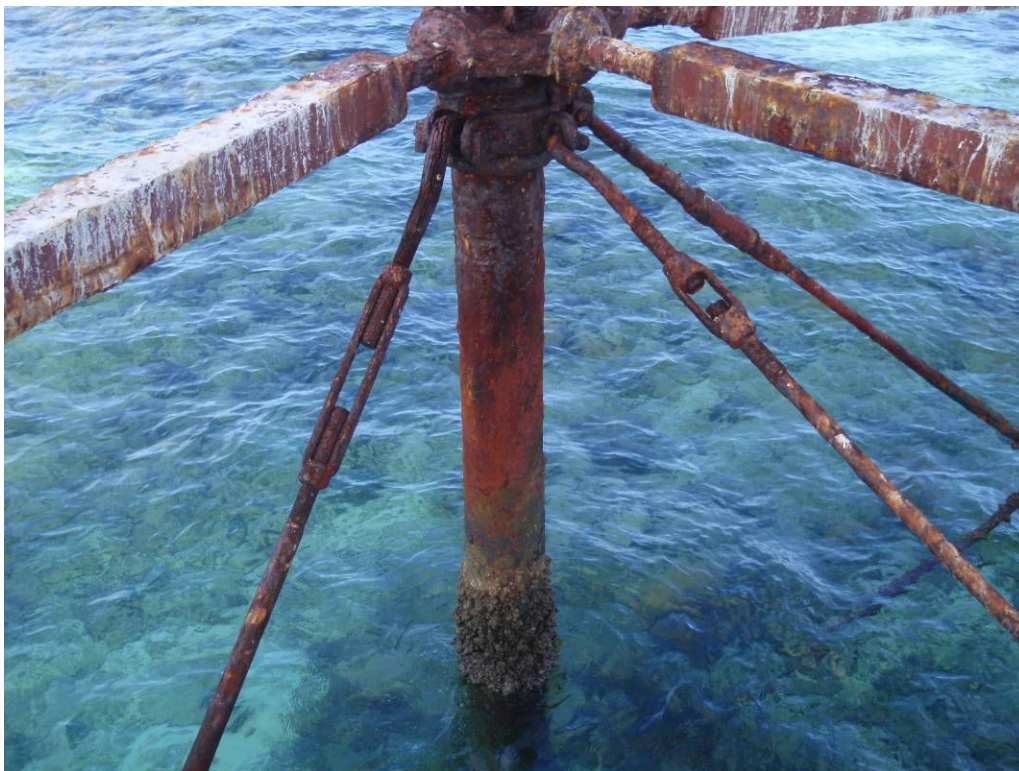
**Photo 6-5**

Coating loss with heavy corrosion and pitting in Section 5.

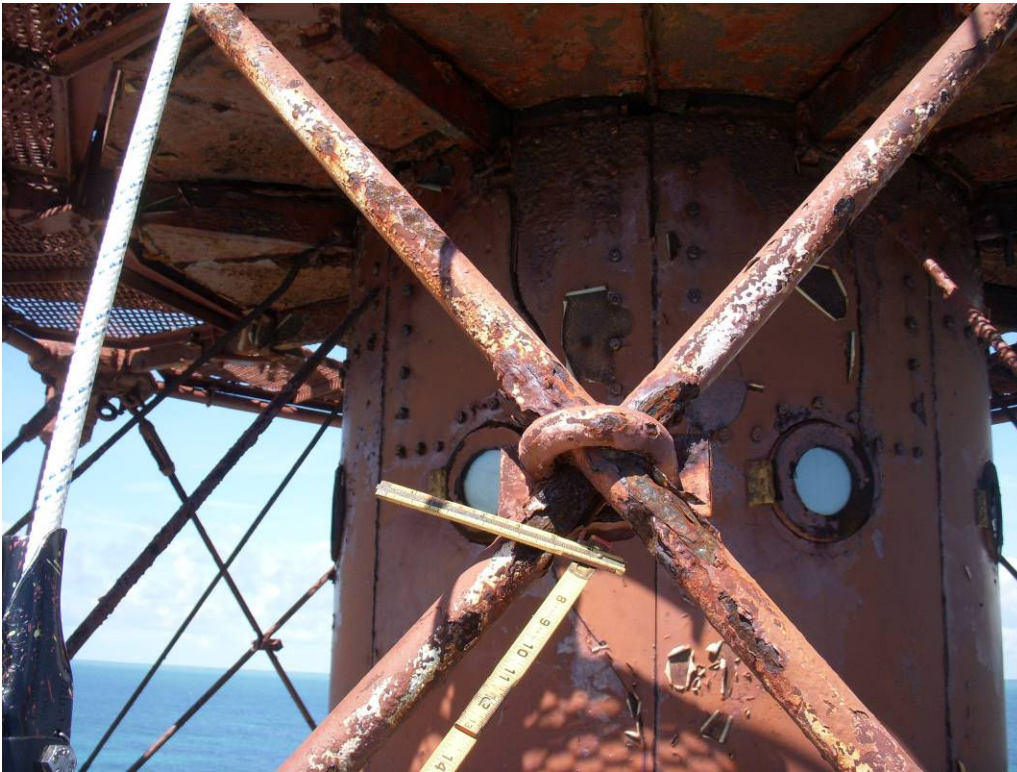
**Photo 6-6**

The tie rods and turnbuckles between panel points are in **fair** condition. Tie rods in Sections 1 and 2 have approximately 30% coating loss with light to moderate corrosion typical. These rods have moderate to heavy corrosion with some pack rust at connection points and at the U-bolt where diagonal tie rods cross (Photo 6-6). Two turnbuckles are broken in Section 1. One leg of the lower turnbuckle on the diagonal tie rod between Column 4 and the stairwell cylinder is broken at the stairwell cylinder (Photo 6-7). The lower turnbuckle on the diagonal tie rod between Column 6 and the stairwell cylinder is broken at the stairwell cylinder (Photo 6-8). At Column 7 in Section 1, 30% of the end of the eye hook at the lower connection of the diagonal tie rod between Columns 6 and 7 has deteriorated away. All horizontal and radial struts are in good condition with minor coating loss.

Typical moderate to heavy corrosion with some pack rust on tie rod.

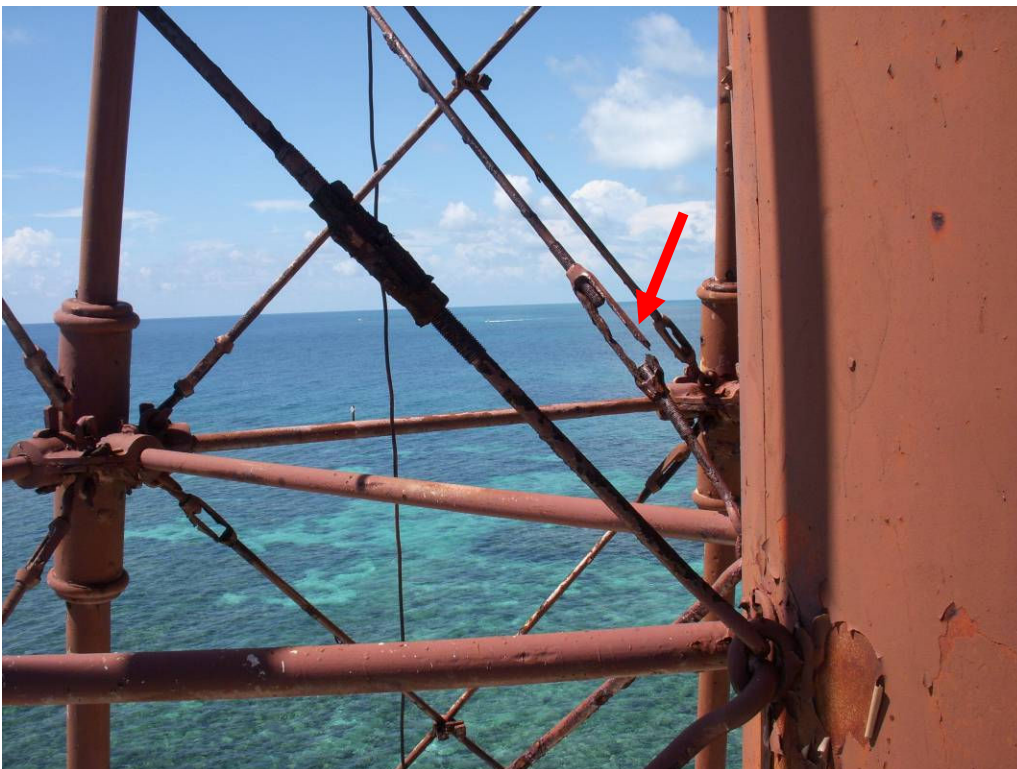
**Photo 6-7**

Broken leg of turnbuckle on tie rod between stairwell and Column 4 in Section 1.

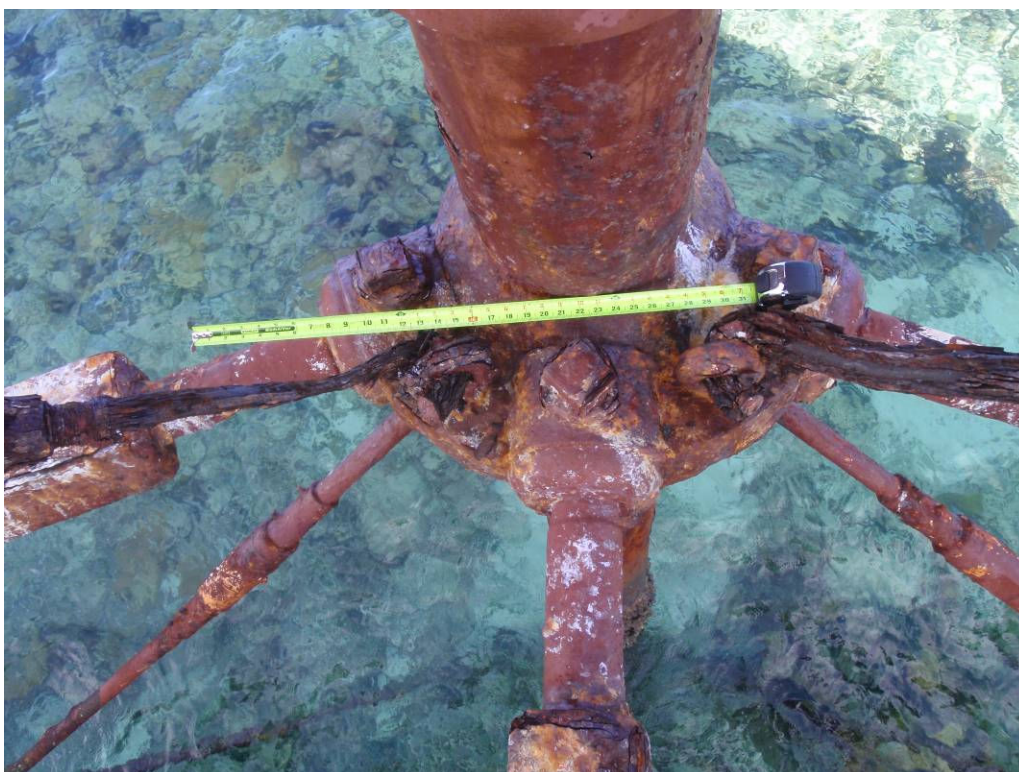
**Photo 6-9**

In Section 4, the upper ends of the diagonal tie rods have moderate to heavy corrosion and negligible section loss. The lower ends of the diagonal tie rods at the column connections are heavily deteriorated with 30% to 50% section loss typical near the end hooks. The lower end of the diagonal tie rod from Column 6 to 7 has 70% section loss at Column 6 (Photo 6-9). Several of the diagonal tie rods are broken below the lower turnbuckle: between Columns 1 and 9 at Column 9 (Photo 6-10), between Columns 3 and 4 at Column 4, between Columns 4 and 5 at Column 5, and both at Column 8.

Section loss on diagonal tie rod at Column 6 in Section 4.

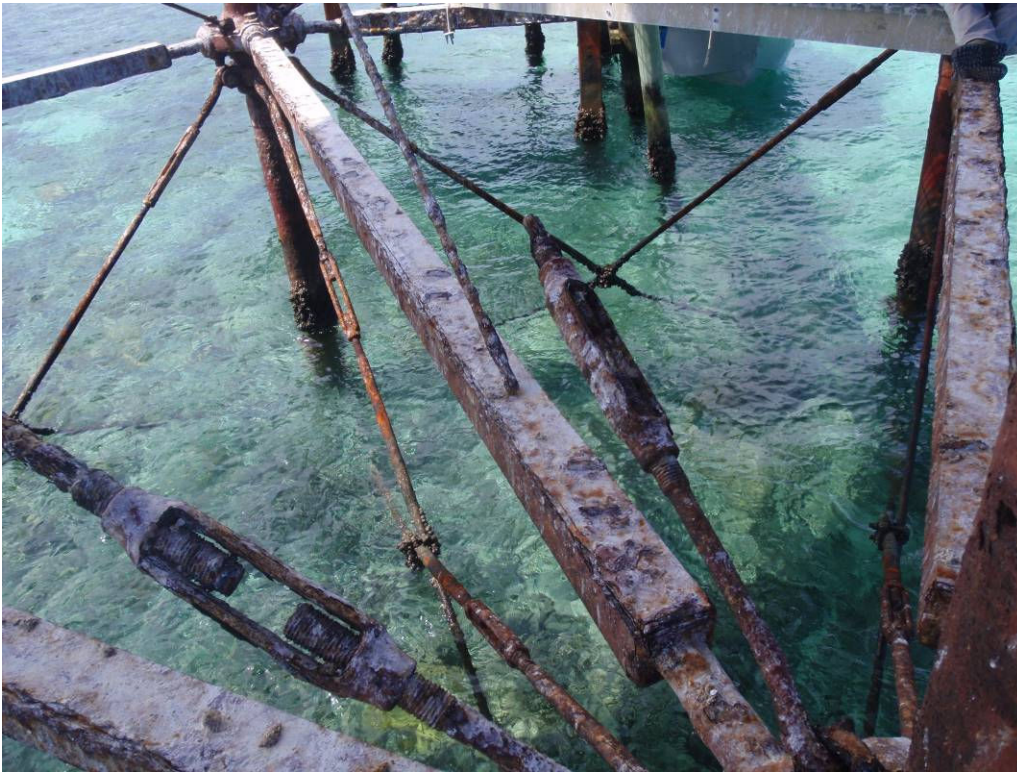
**Photo 6-10**

Broken tie rods in Section 4 between Columns 1 and 9.

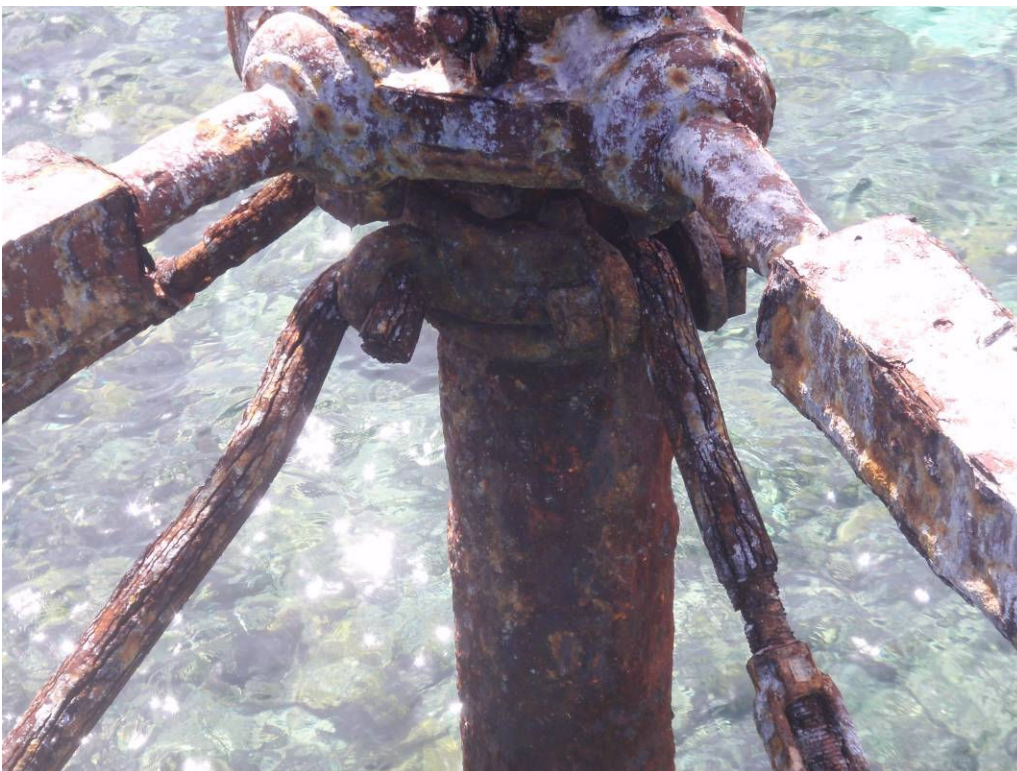
**Photo 6-11**

In Section 5, the upper ends of the diagonal tie rods are heavily corroded, primarily at Columns 1, 7, and 8 (Photo 6-11). The radial and horizontal struts at the top of Section 5 have moderate to heavy corrosion with isolated areas of delamination.

Heavily corroded tie rods in Section 5 at Column 8.

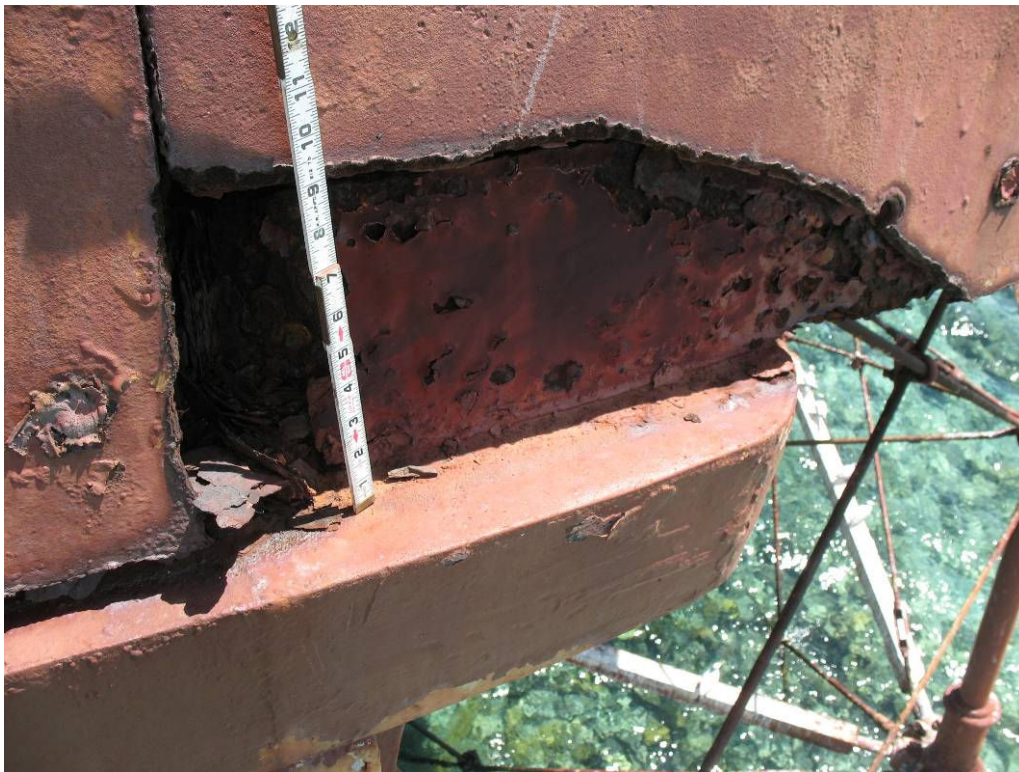
**Photo 6-12**

The exterior of the dwelling has approximately 15% coating loss with light corrosion. All of the shutters are in good condition. There are isolated areas of corrosion and pitting up to 4" diameter and up to 1/4" deep throughout. The bottom 8" to 10" of all wall panels has cracks up to 1/4" wide at random locations; some pieces are fractured off (Photo 6-12).

Typical fractured dwelling wall panel.

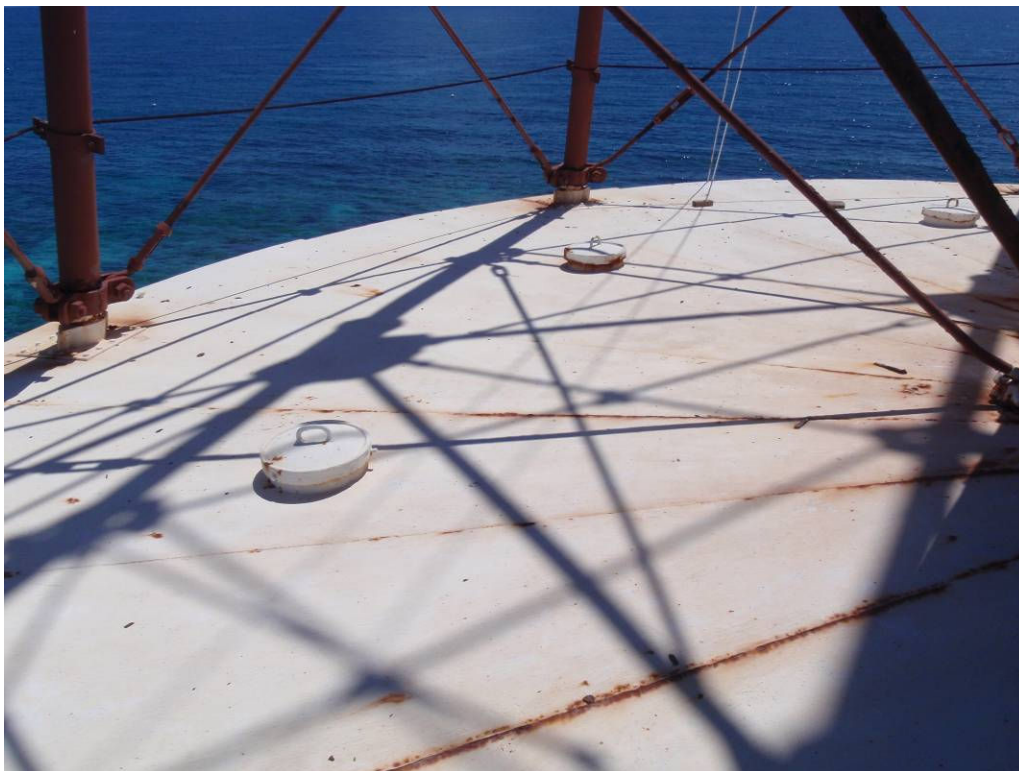
**Photo 6-13**

Light corrosion on steel safety cable around the dwelling roof.

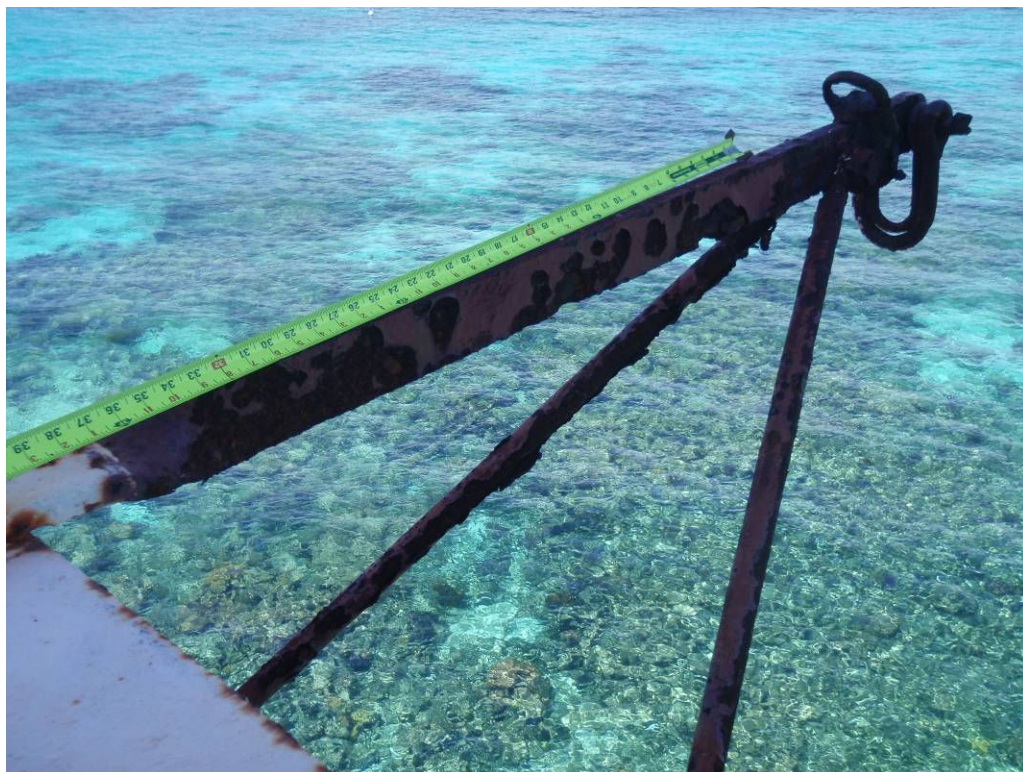
**Photo 6-14**

The roof membrane is in good condition with minor rust stains at the edges of the roof plates. There are up to 1" vertical offsets between roof plates; however, this condition was likely as-built. The roof has eight hatches which are in good condition with minor coating loss and light corrosion. A steel safety cable circles the perimeter of the roof and has light corrosion (Photo 6-13). An iron davit is located on the north side of the dwelling exterior between Columns 1 and 8. The davit assembly has 50% coating loss. The primary davit member is heavily corroded with 20% section loss (Photo 6-14).

Heavily corroded davit on dwelling roof.

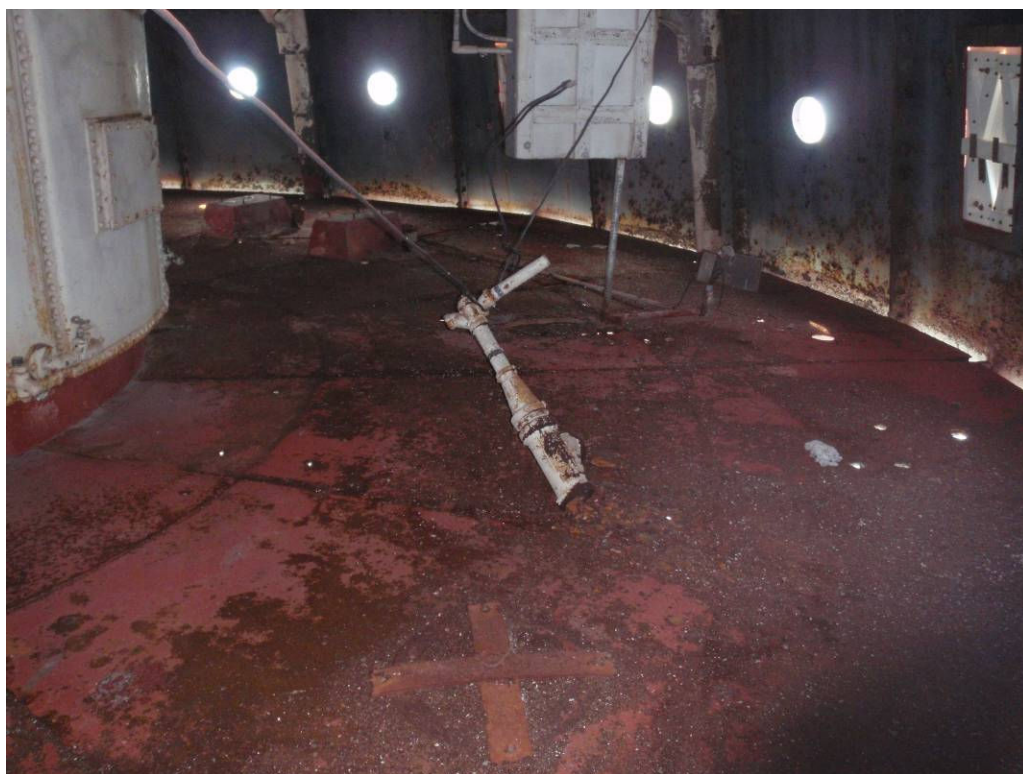
**Photo 6-15**

The underside of the floor has approximately 40% coating loss with light corrosion. On the interior, the floor has 80% coating loss with light to moderate corrosion and random areas of heavy pitting (Photo 6-15). The entrance hatch has heavy corrosion with up to 1/16" deep pitting (Photo 6-16). Fifty percent of each of the vent/drain grates in the floor have 100% section loss (Photo 6-17). Two of the grates near Columns 2 and 4 have been plugged with solid timber covers. Floor plates around Columns 1, 2, 5, 7 and 8 have heavy corrosion with up to 100% section loss extending as far as 7" away from the column (Photo 6-18). Near Columns 2 and 8, the floor plates are cracked up to 34" long due to buckling of the plates. Near Column 3, the outer floor plate is depressed up to 1 1/2" with a 1" wide gap between floor plates.

Light to moderate coating loss and heavy pitting on the first floor dwelling interior.

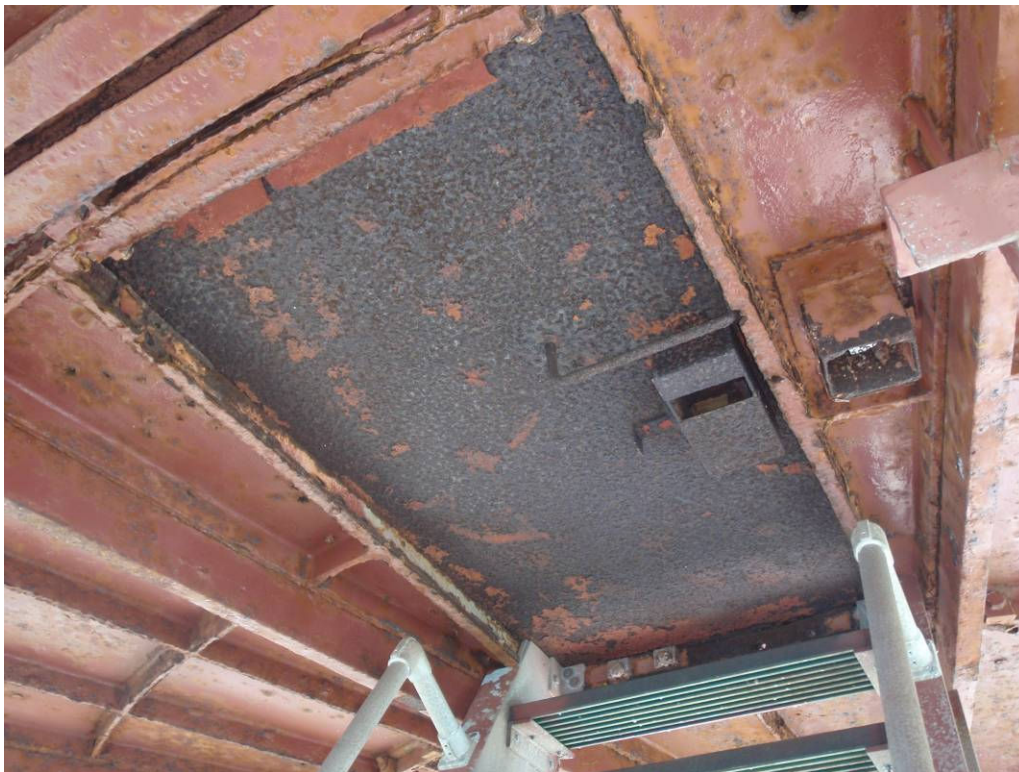
**Photo 6-16**

Heavy corrosion and 1/16" deep pitting on entrance hatch.

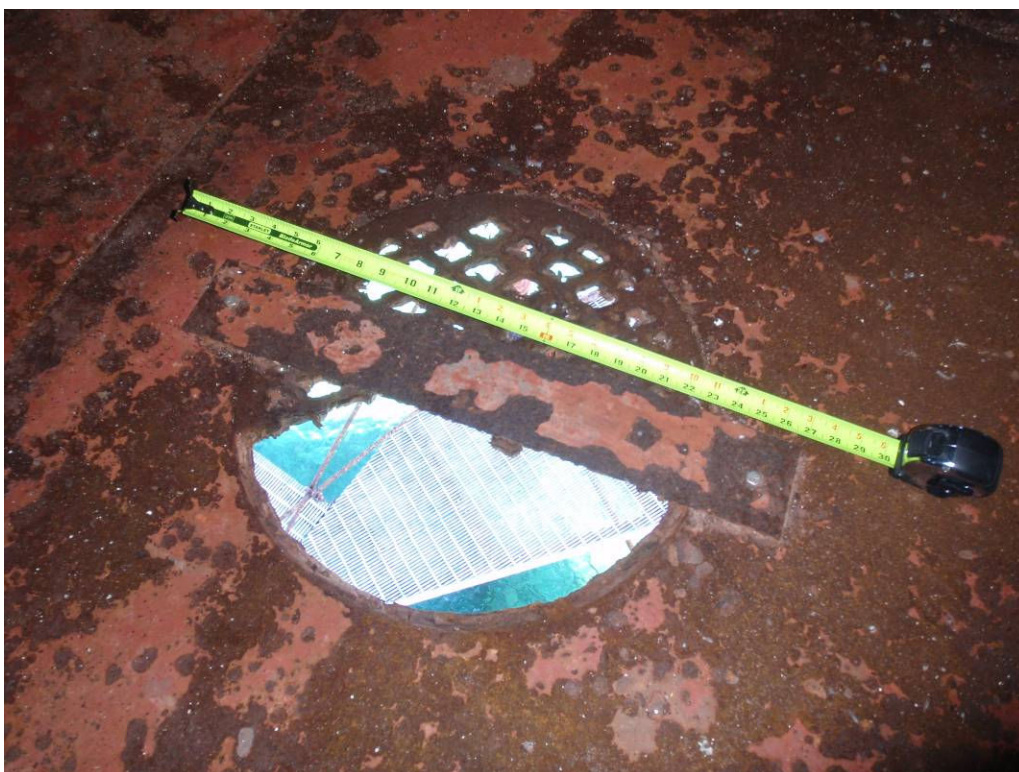
**Photo 6-17**

Typical 100% section loss on vent/drain grates on first floor of dwelling.

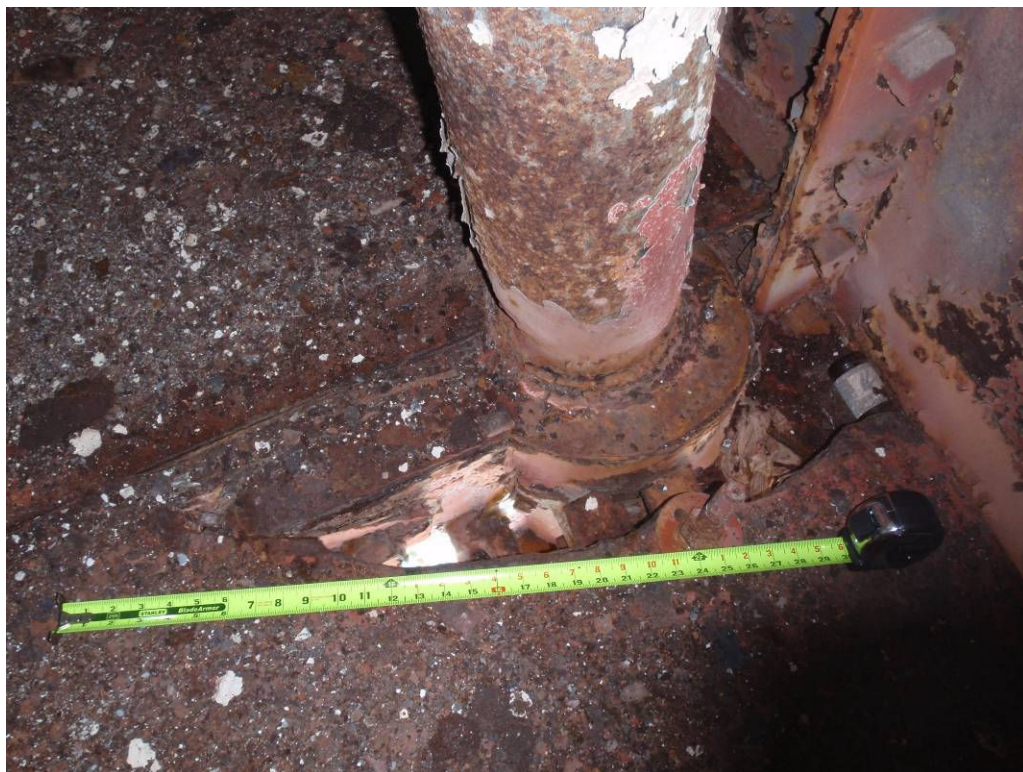
**Photo 6-18**

Heavy corrosion with section loss on first floor dwelling floor plates, shown at Column 7.

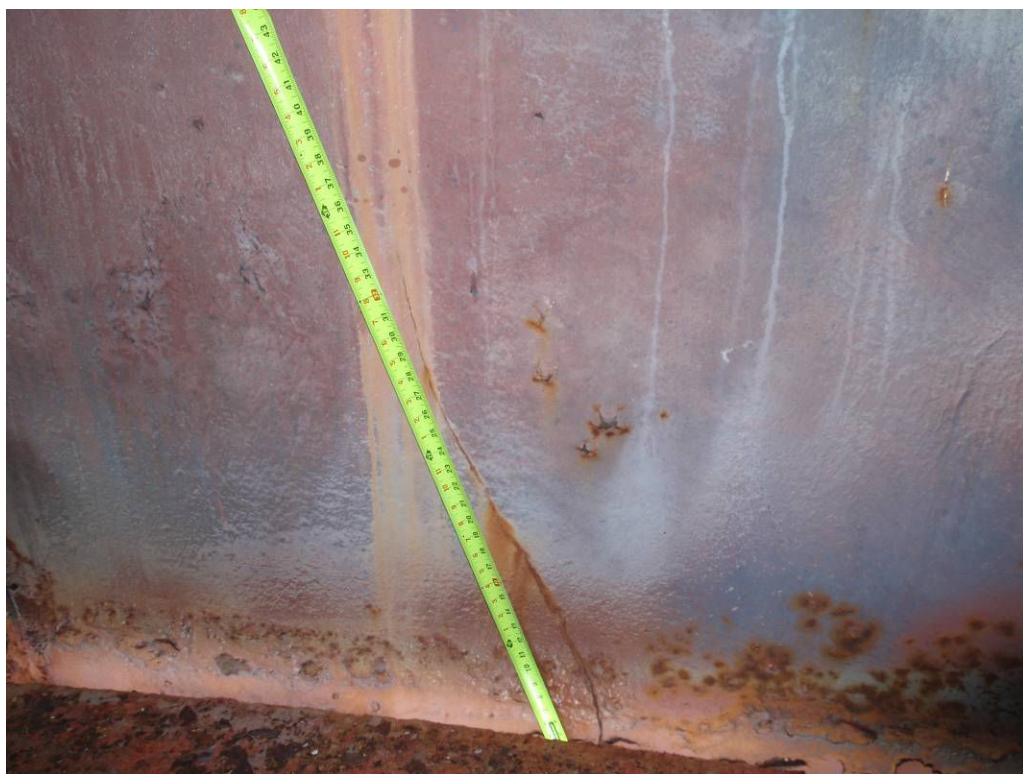
**Photo 6-19**

Vertical crack with rust stains in dwelling Wall Panel 24 on first floor.

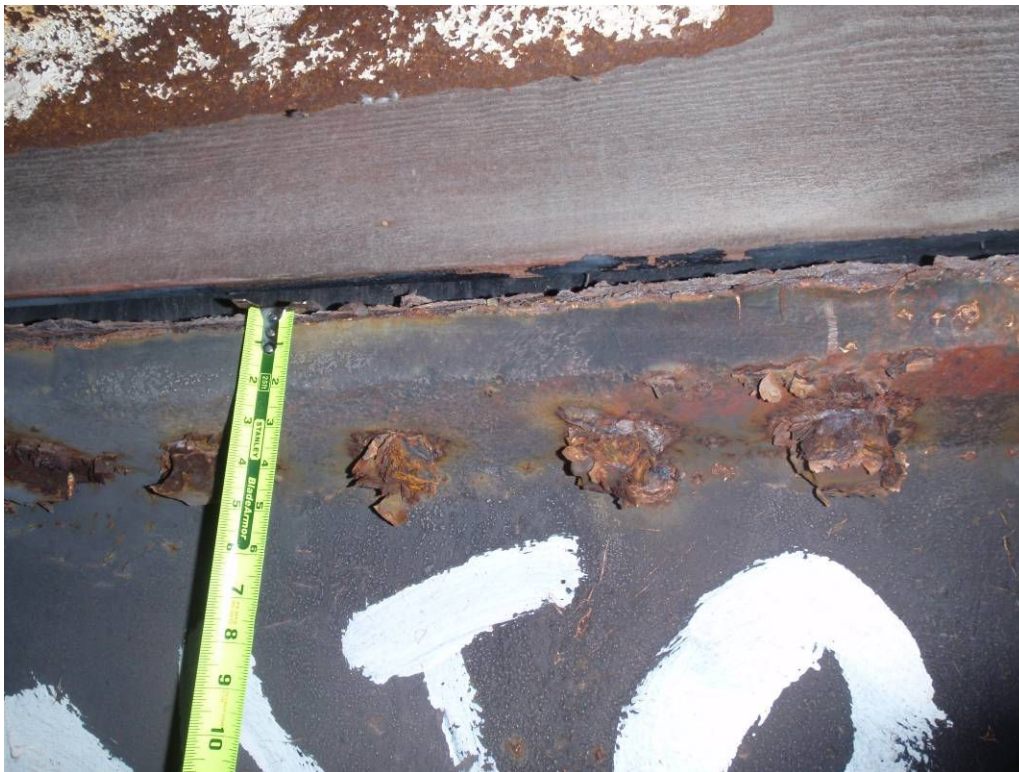
**Photo 6-20**

Typical corrosion on dwelling wall panel bolts.

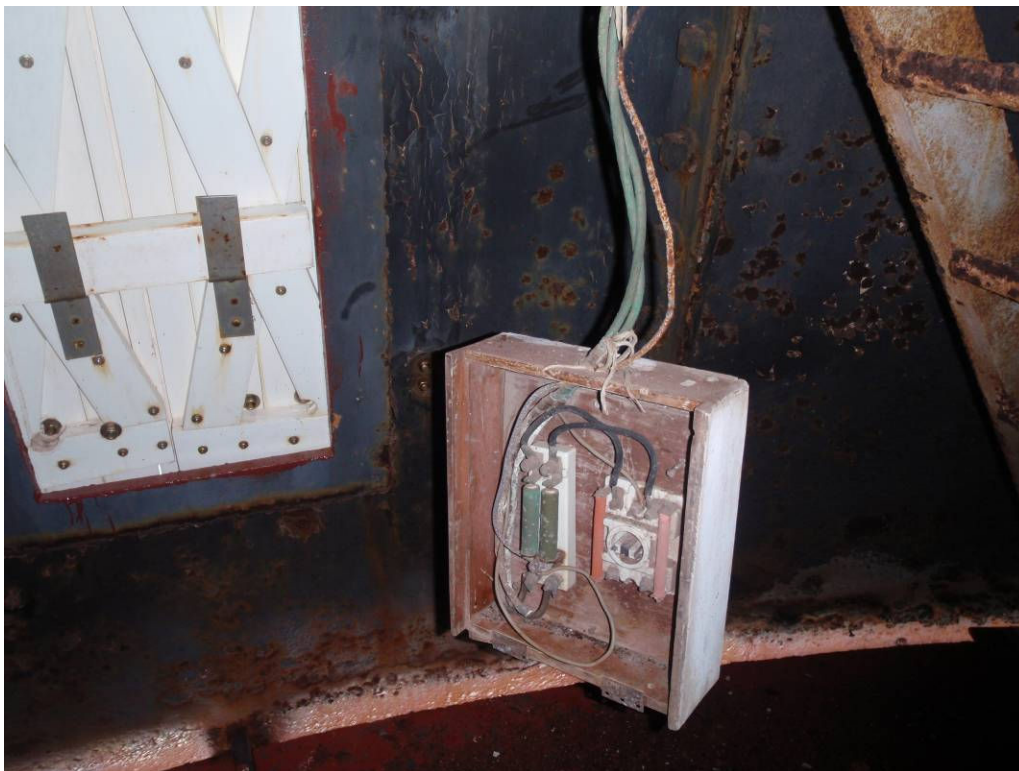
**Photo 6-21**

The interior walls have approximately 30% coating loss with random areas of corrosion and pitting throughout; corrosion and pitting is more advanced in the lower third of each of the wall panels. The glass in the portholes in Wall Panels 2, 4 and 5 are broken. Wall Panel 24 has an up to 1/32" wide x 34" long vertical crack with rust stains (Photo 6-19). Bolts connecting wall panels have light to moderate corrosion; isolated bolt heads at Panel 3 are heavily corroded with up to 30% section loss (Photo 6-20). The ceiling has approximately 60% coating loss, primarily near the exterior wall with light to moderate corrosion. Handrails around the entrance hatch are missing. The fresh water tank is in good condition with light corrosion around plate edges and rivets. All electrical systems are non-functional and wiring is exposed in several locations (Photo 6-21).

Typical non-functional electrical system with exposed wiring.

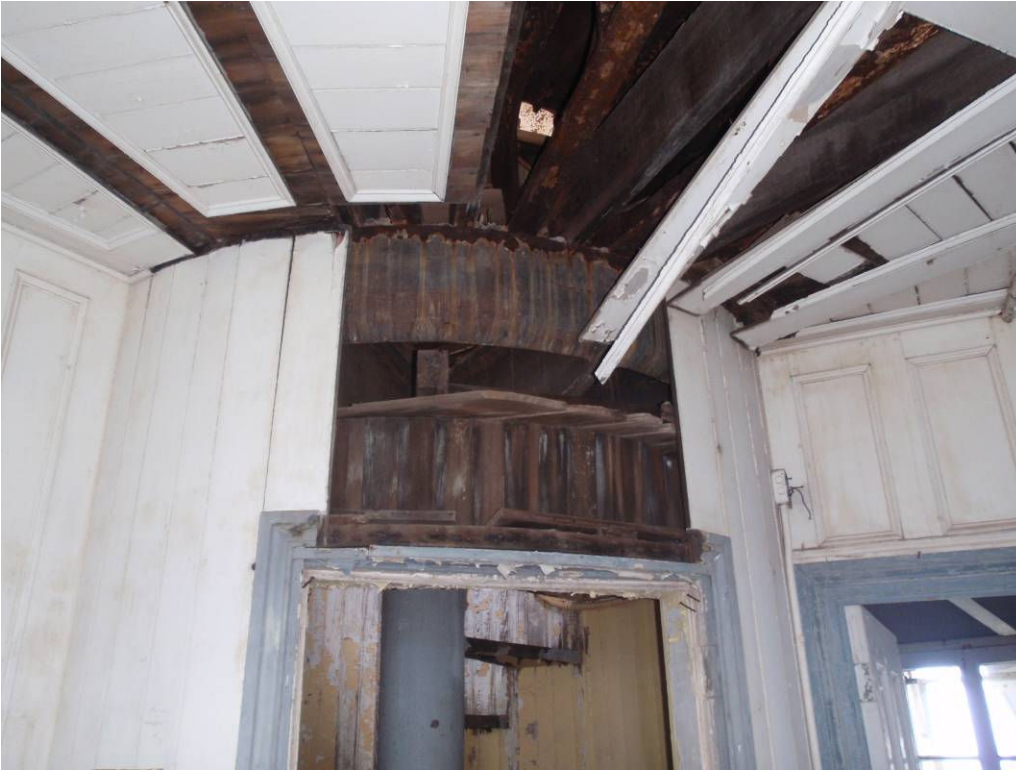
**Photo 6-22**

entrance to the tower stairwell in Room 1. Approximately 60% of the ceiling paneling is missing in Room 1 (Photo 6-22). All kitchen fixtures are inoperable.

Missing ceiling and wall paneling in Room 1 on the dwelling second floor.

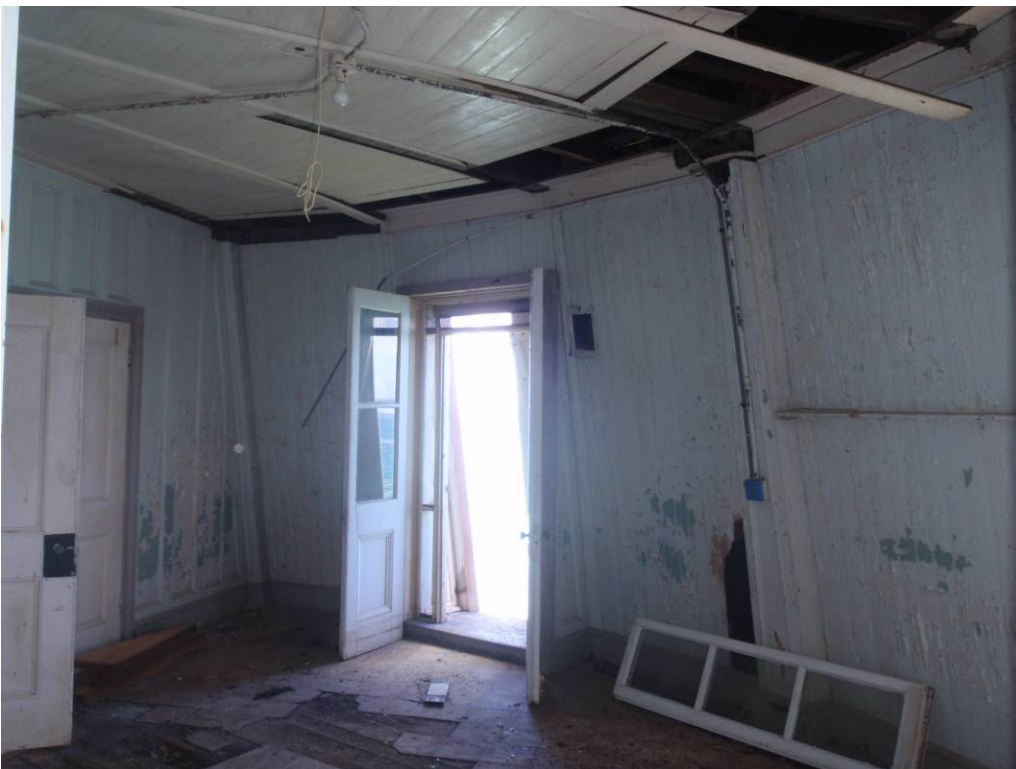
**Photo 6-23**

In Room 3, approximately 30% of the ceiling paneling is missing and there is a 1' wide x 3' high hole in the base of the wall paneling (Photo 6-23). Approximately 40% of the ceiling paneling is missing in Room 4. Also in Room 4, the flooring in the portico beyond the exterior door has moderate deterioration.

Missing ceiling paneling and hole in base of wall panel in Room 3 on the dwelling second floor.

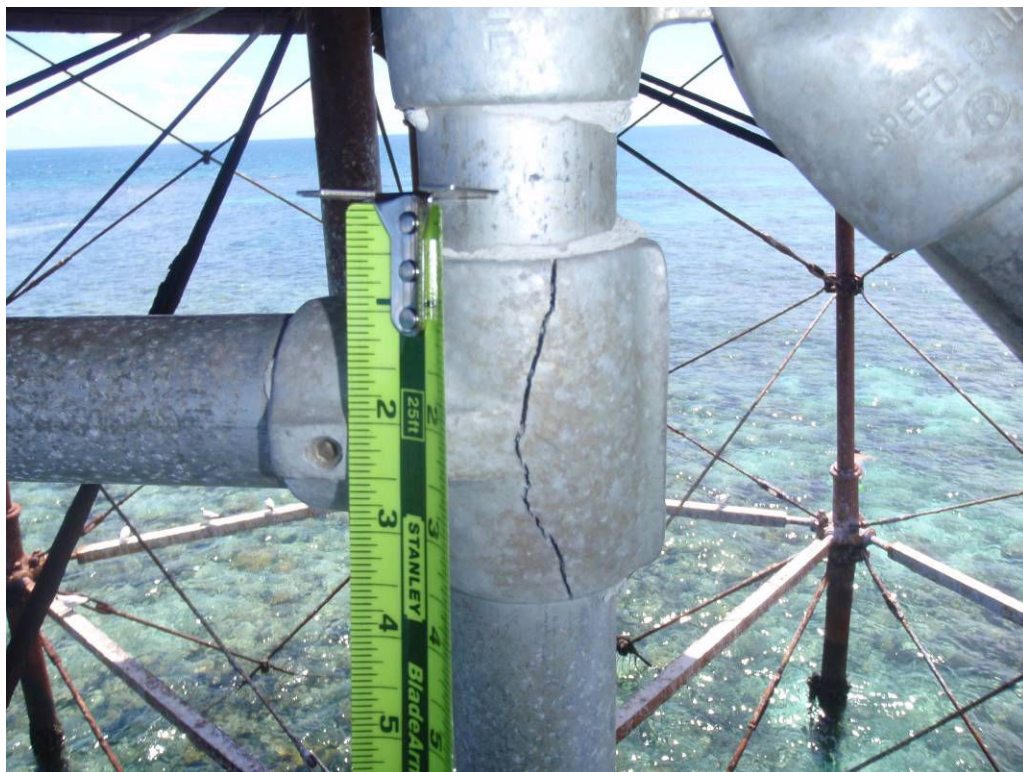
**Photo 6-24**

The boat landing is in **fair** condition. Two handrail brackets at the second stair landing are broken (Photo 6-24). Two U-bolts that secure the deck grating to the horizontal strut at the first landing are broken. Two timber beams support the walkway from the boat landing to the first stair landing. One of these beams has heavy deterioration around the bolt holes at the first landing (Photo 6-25). A 12' by 8' area of deck grating at the southwest corner of the boat landing is missing clips intended to hold it to the steel frame. The steel frame supporting the landing has moderate to heavy corrosion with multiple small perforations in the webs (Photos 6-26 and 6-27). The concrete pile at the southeast corner of the boat landing has an area of spalling and delamination around the full perimeter of the top 2' of the pile (Photo 6-28). Steel collars at the tops of all of the boat landing piles have heavy corrosion.

Broken handrail bracket on exterior stairwell in Section 4.

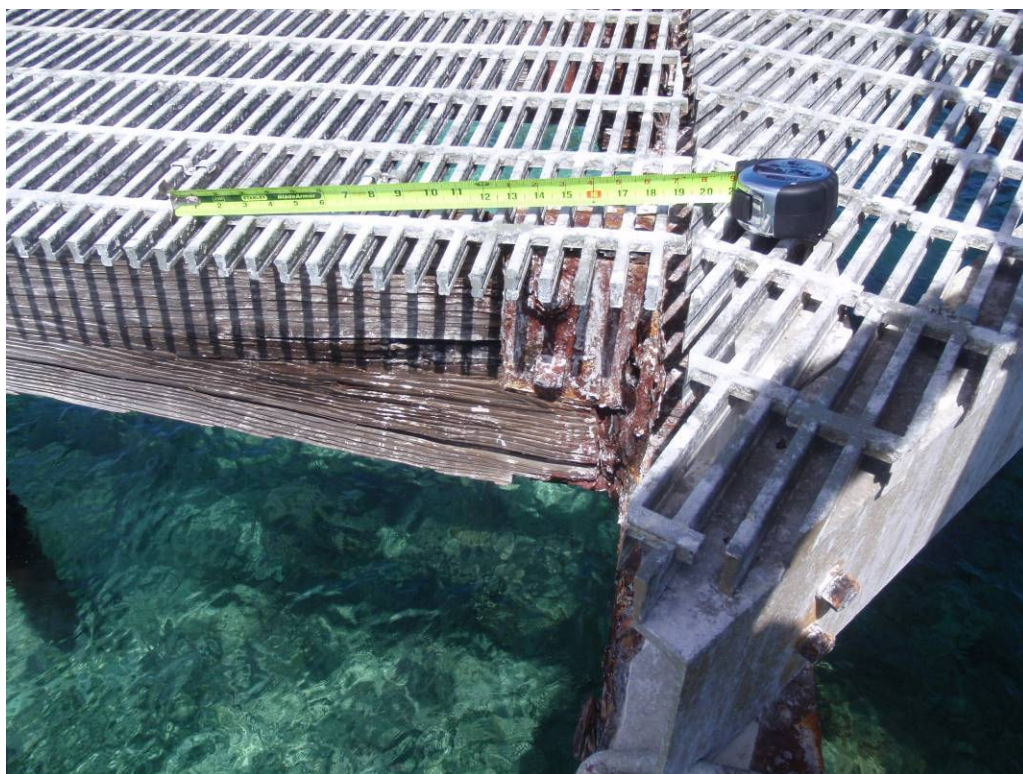
**Photo 6-25**

Heavy deterioration of the timber boat landing walkway beam at connection.

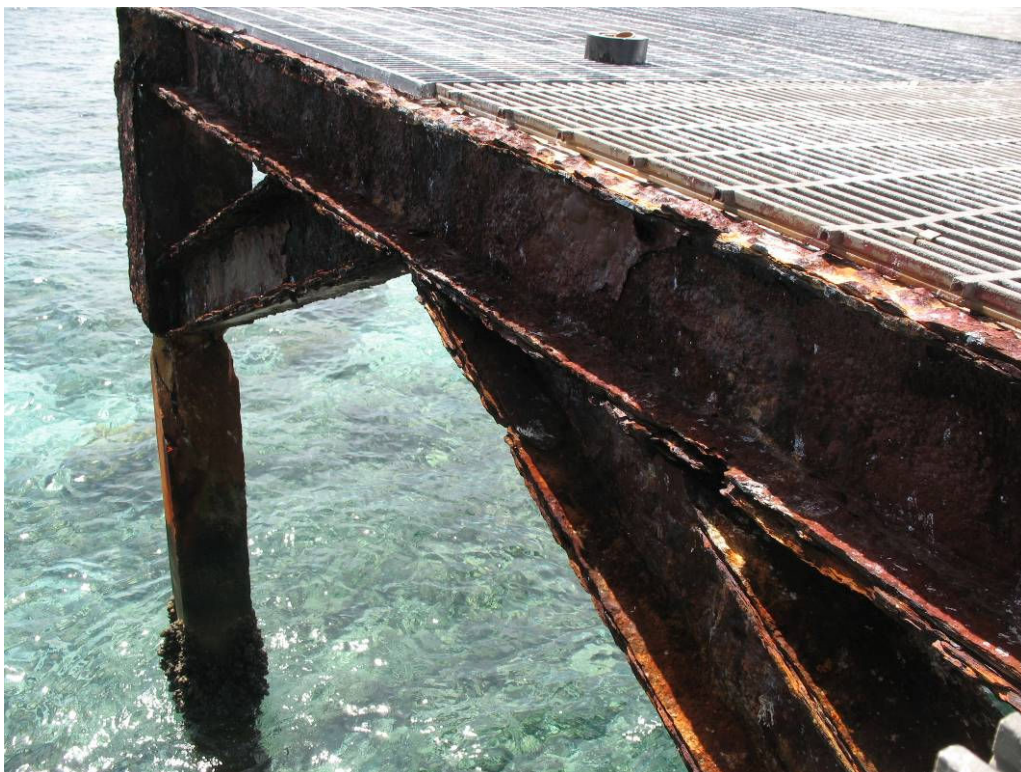
**Photo 6-26**

Moderate to heavy corrosion on steel frame with multiple small perforations in webs.

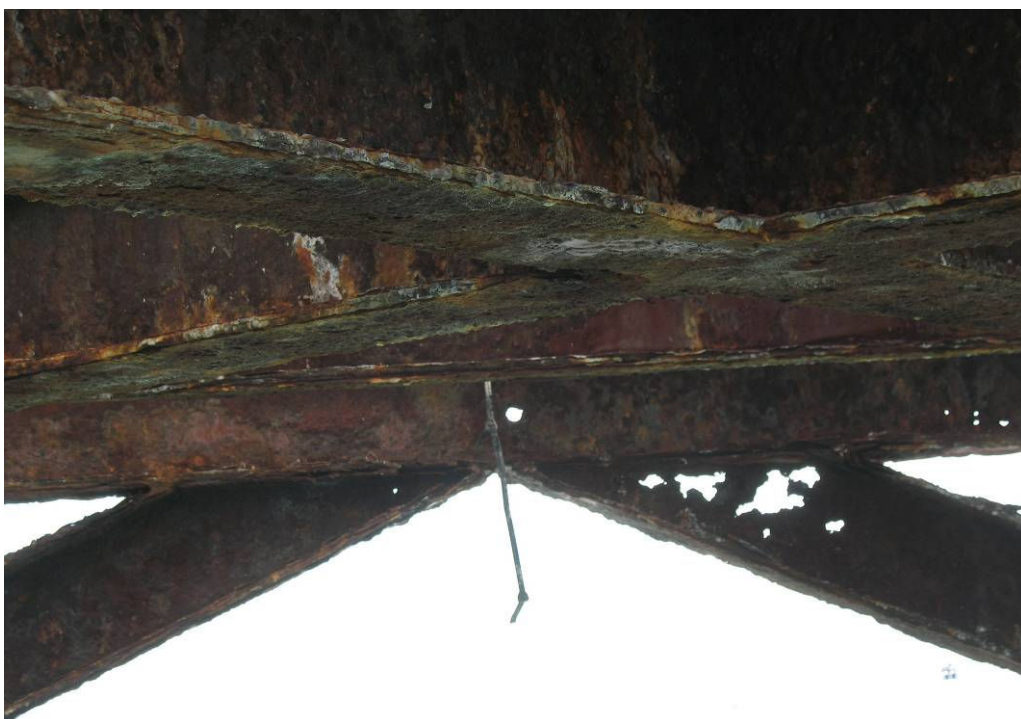
**Photo 6-27**

Moderate to heavy corrosion on steel frame with multiple small perforations in webs.

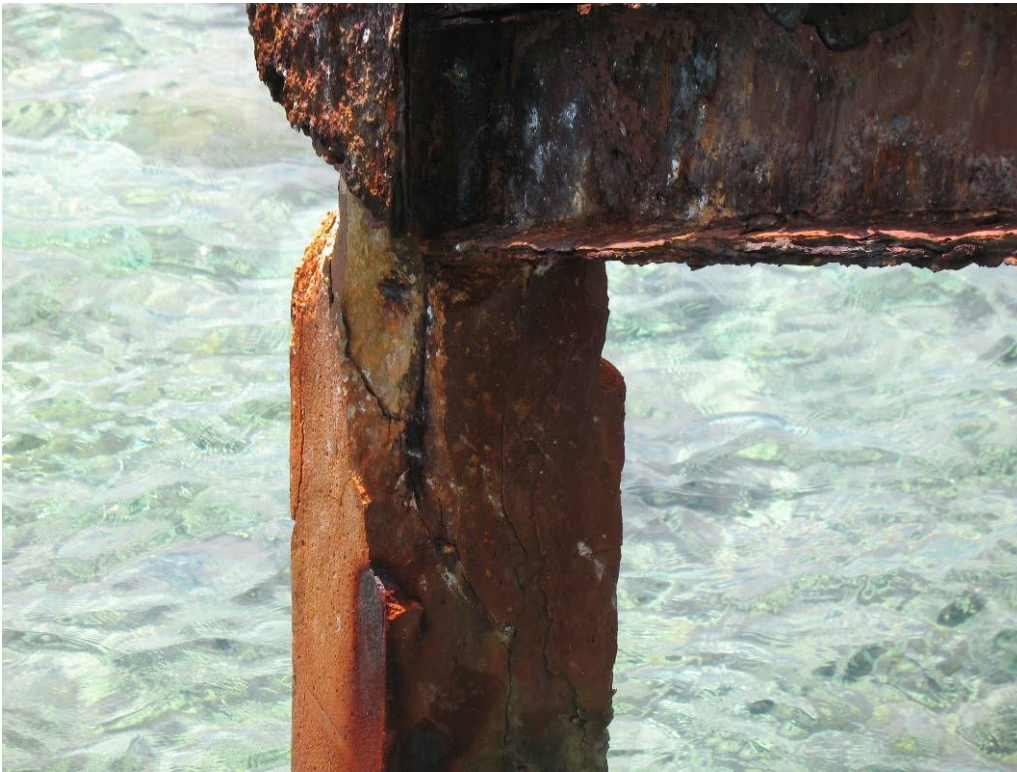
**Photo 6-28**

Area of spalling and delamination on boat landing concrete pile.
